## Minerals Inspection Report

Report Date: **March 31, 2015**

Mine Name: Three Knolls	Permit Number: S/027/0101	Mine Status: Reclaimed
Operator Name: Western Clay Company	Inspection Date: 9/11/2014	Permit Fees: No Fee Req.
Inspector(s): Peter Brinton	Inspection Time: 8:25-8:40am	Bond Amount: \$4,000
Attendee(s): none	Weather: cool, clear	Bond Escalation: n/a
Inspection Purpose: Revegetation inspection		Prior Inspection: 08/05/2014

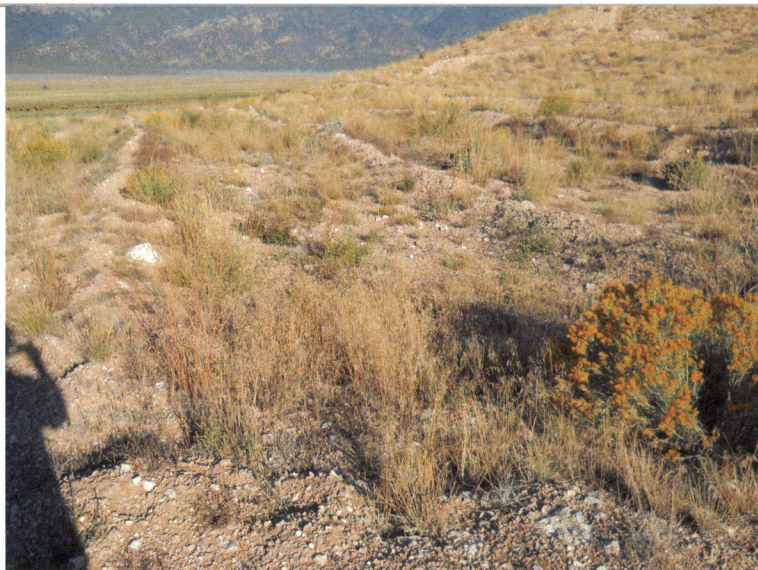
Patch of cheatgrass near the edge of the regraded area, with primarily beneficial vegetation in the background.

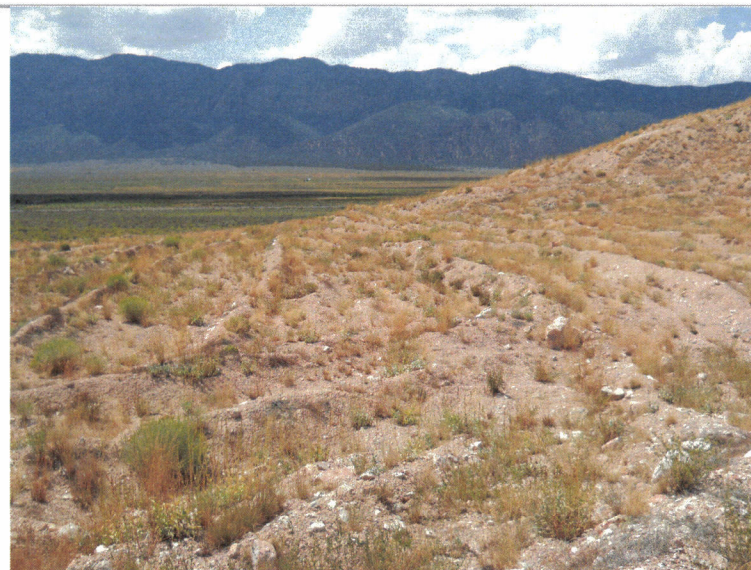
It was noted that seeded species (and to a lesser extent, weeds) did not typically grow on the south-facing sides of the notable furrows.			
10.	Other	<input checked="" type="checkbox"/>	<input type="checkbox"/>
A few photographs included below are from the August 2014 inspection.

August 2014 photo of established grasses and areas of lesser vegetation on sides of furrows.

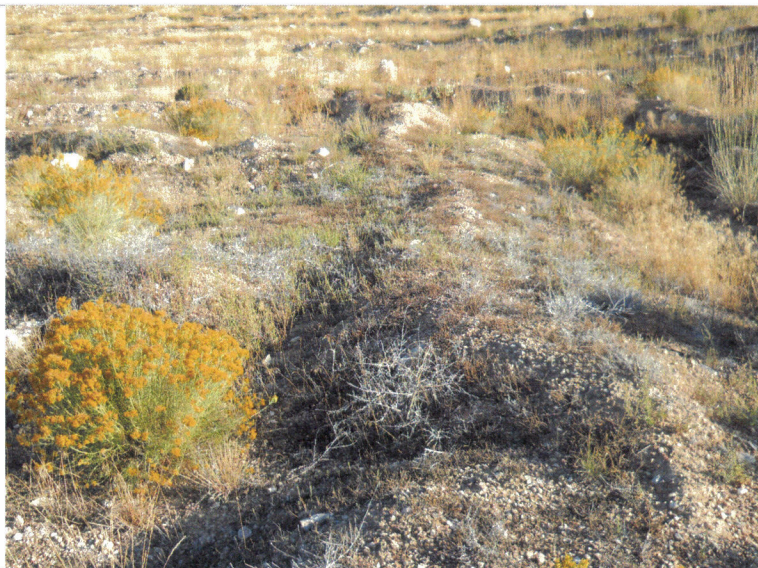
Patch of weed skeletons in a less successful spot. There are a few spots like this, but most areas consist of successful vegetation with relatively minor weeds.

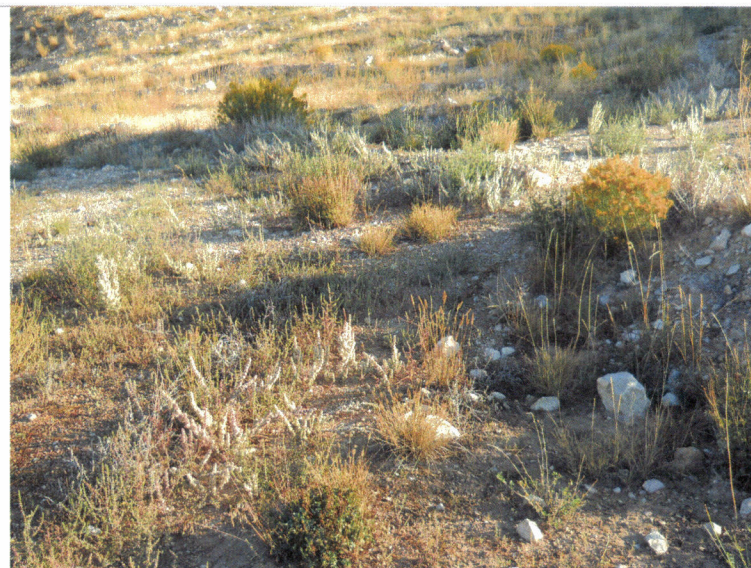
Example of diverse vegetation with a weedy component.

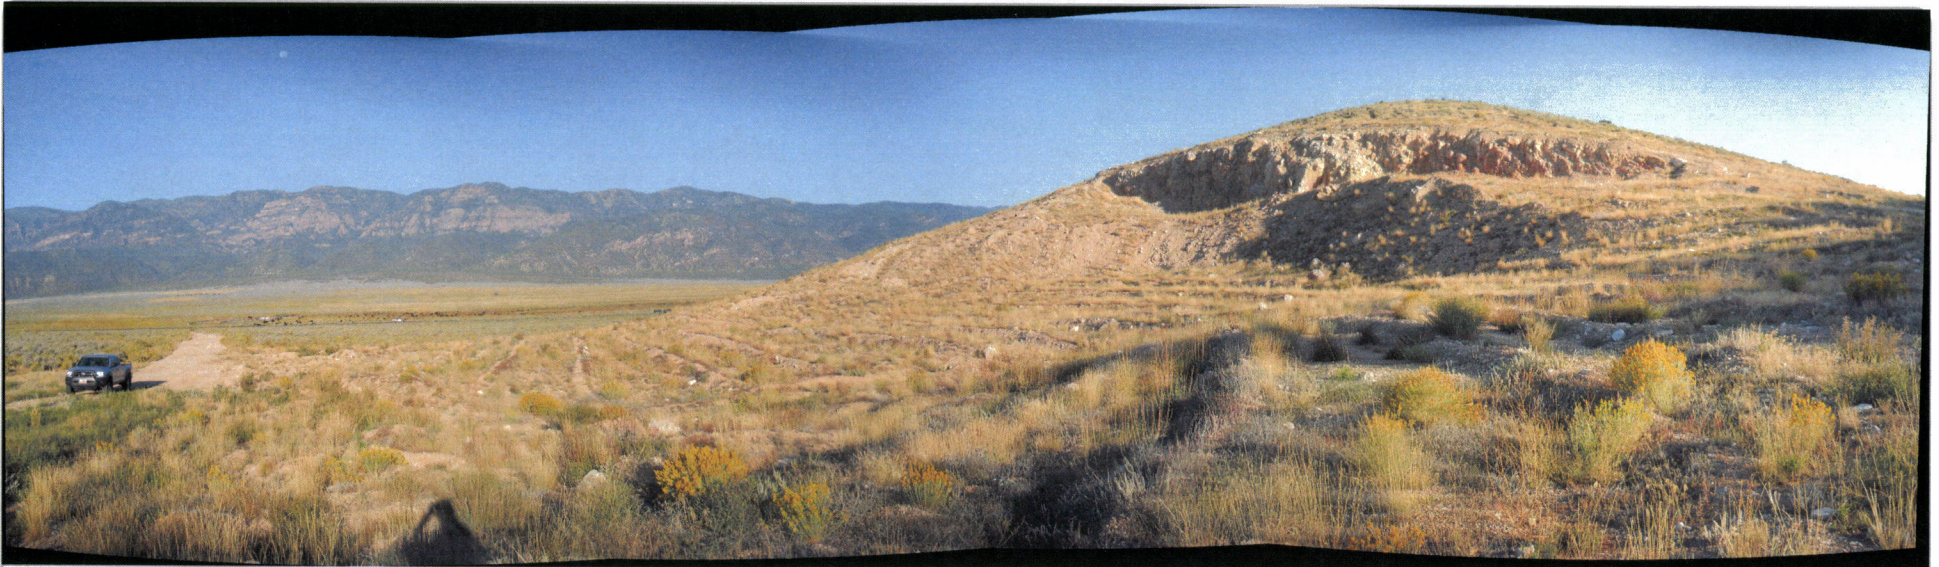
View of revegetated quarry, looking roughly west-northwest. Stitched photo.

Revegetation standards have been met, and a beneficial vegetative cover of diverse species (with a notable, but relatively minor weed component) is established. It is recommended that Western Clay Company request full bond release and file closure.

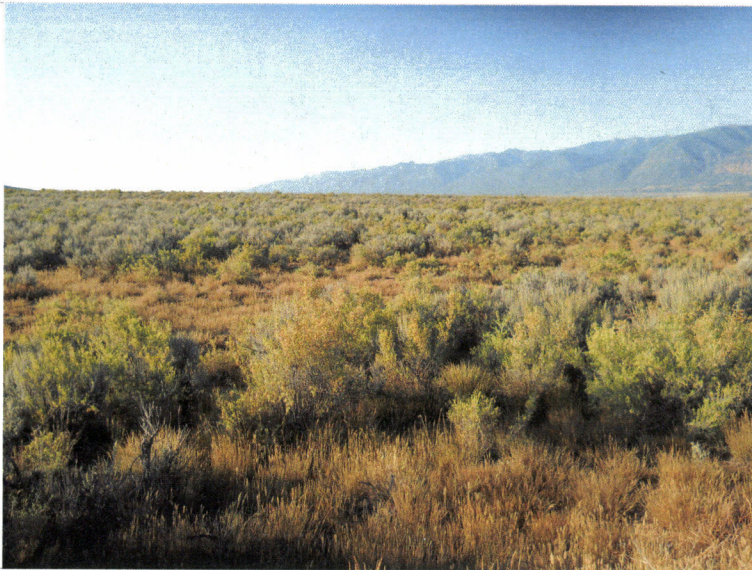
Example of adjacent undisturbed areas with good cover, following August rains.

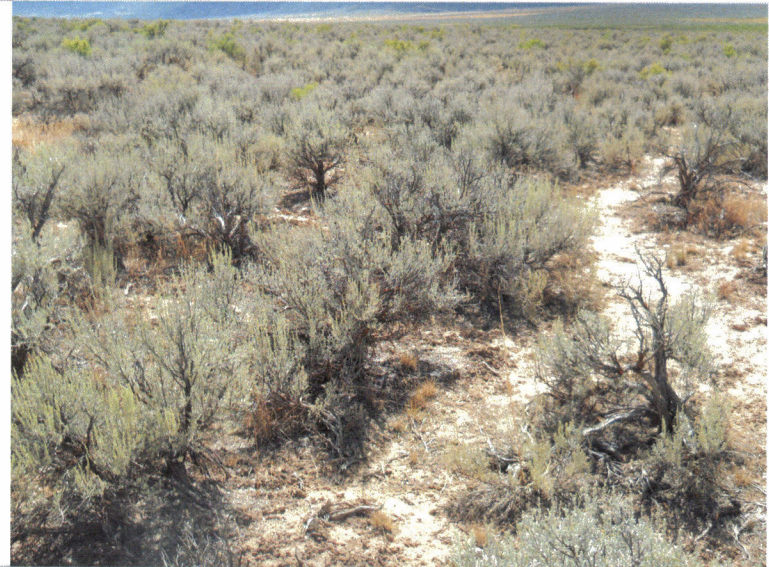
Example of undisturbed adjacent areas with varying quality of vegetation. Cheatgrass and some other grasses are present with sagebrush. Note the bare soil. (August 5, 2014 photo)
